MOTOR GRADER TEST

Rome Grader - Model 402,

San Bernardino National Forest,

January 23 - March 15, 1950

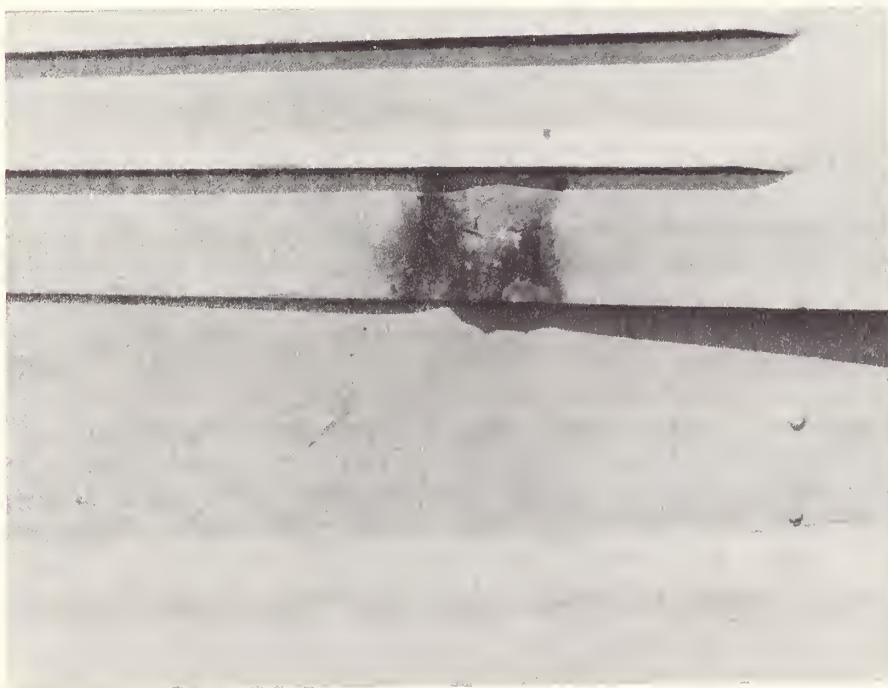
The sizes and weights of the box section frame are average as compared to other machines. However, due either to design or weight distribution on the frame itself, the frame showed extreme flexibility. From chalk marks put on the rear of the cab, it was shown that the relative motion between the vertical center lines of cab and engine was approximately 2°. This flexibility was extremely noticeable in the heavier work such as encountered in the ditching tests, but was evident during all operations. Flexing in this respect will ordinarily result in eventual structural failure and may be a decided factor in blade flexibility complaints which are discussed under Blade Operation. The arrows in photograph, Fig. 7, show the range of this movement.

Fig. 7. Flexing shown by Arrows on Cab

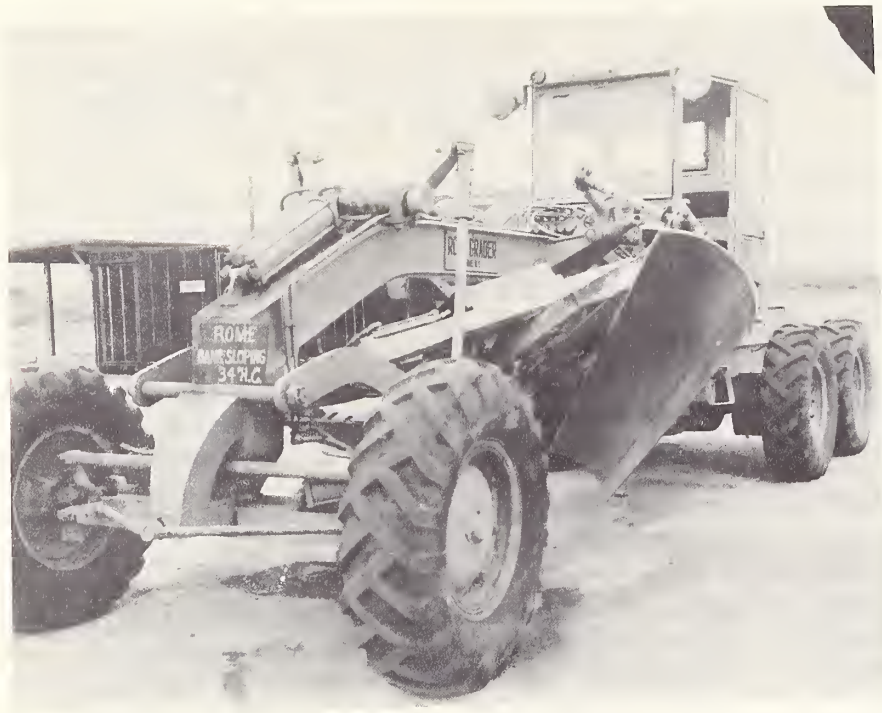
It should be noted that on slopes up to 53° the heel of the blade was inside the wheel reference line, as shown in photograph - Fig. 10. It had the effect of making the blade incapable of touching a bank below the point where the blade passed the tires. Later field trials showed this to be true unless the machine was driven up on the bank being sloped. The photograph shown in Fig. 11 clearly indicates that in order to slope the bank, it was necessary for the machine to be driven along the bank itself. If the machine was not run on the bank, gouging of the road with the heel of the blade resulted. The particular photo shown was on an out-curve. On in-curves and tangents this difficulty would be aggravated.

Fig. 10. Bank Slope Angle $1\frac{1}{2}:1$

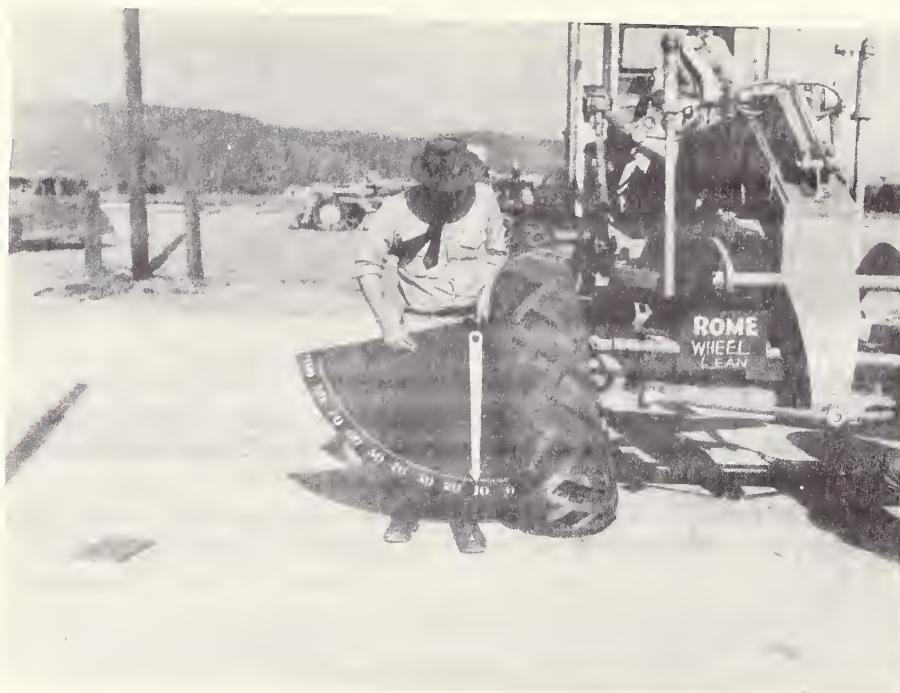
Fig. 12. Rome Wheel Lean -- Right

There was no published data to indicate what the designed wheel lean should be. It is assumed, however, that when corrected to equalize right and left lean, the final setting would approximate 13° . This is considerably less than the lean accepted by other manufacturers as desirable.

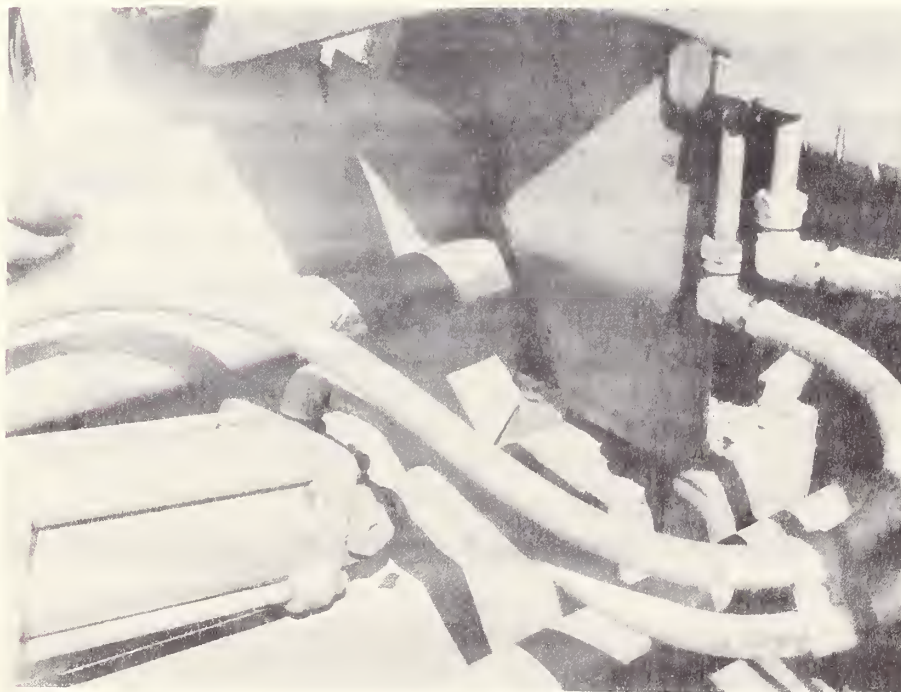
Fig. 13. Cross Stabilizer Wear

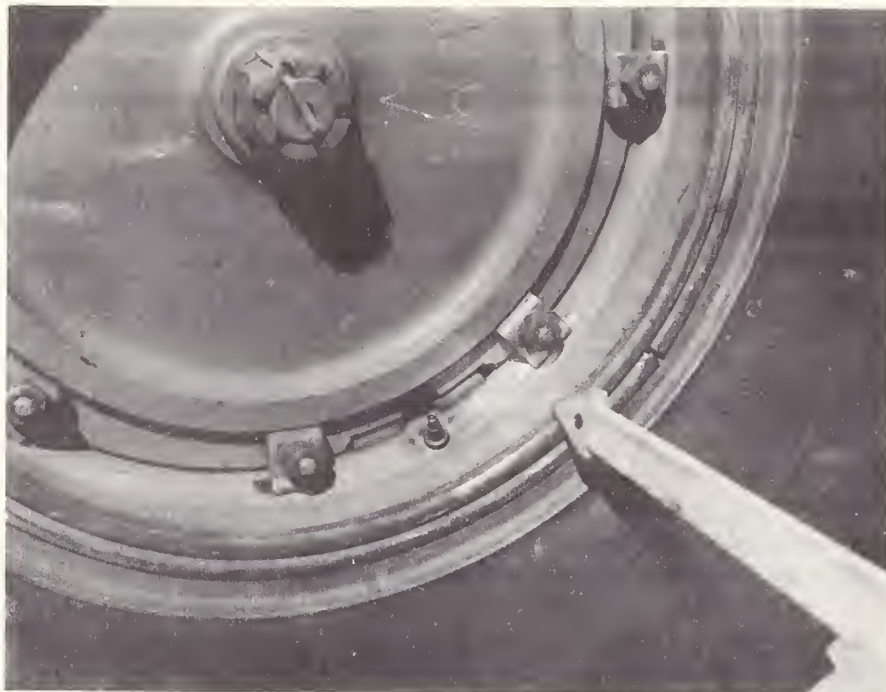
Fig. 16. Rim Slip

Previous experience with rim mountings of this type indicates that satisfactory operation can only be obtained by welding lugs solidly to rim. It is recognized that the rim is of standard make and designed for grader service. The fact remains, however, that the rim failure on the Rome was the only trouble of this kind experienced during the entire test.

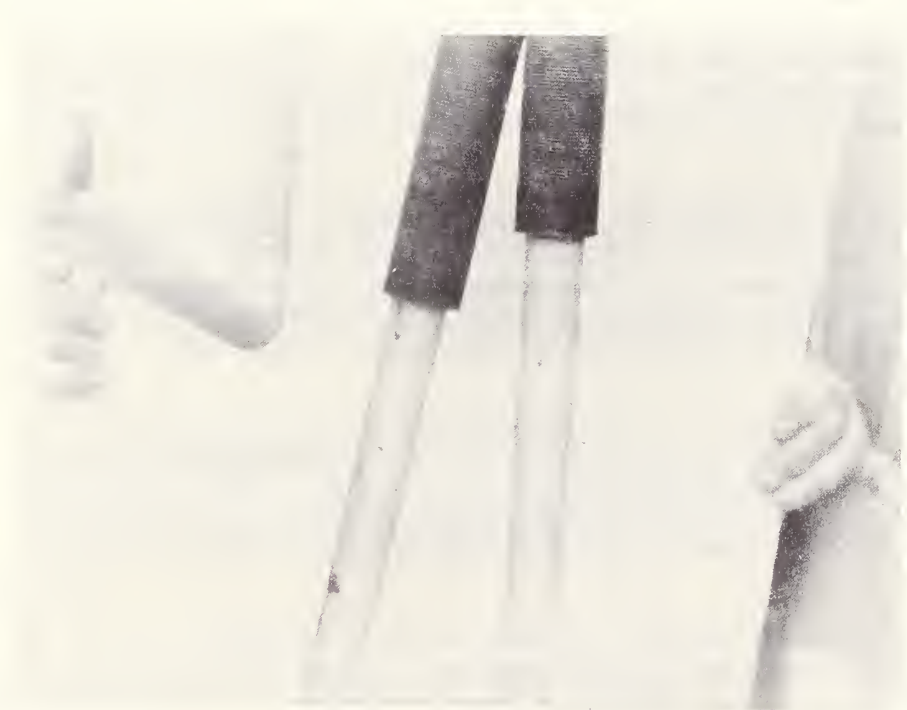
2. Shift Levers. The hi-low shift lever interfered with the main shift lever when it was in back (hi) position. Refer to Fig. 17.

Fig. 17. Shift Lever Interference.

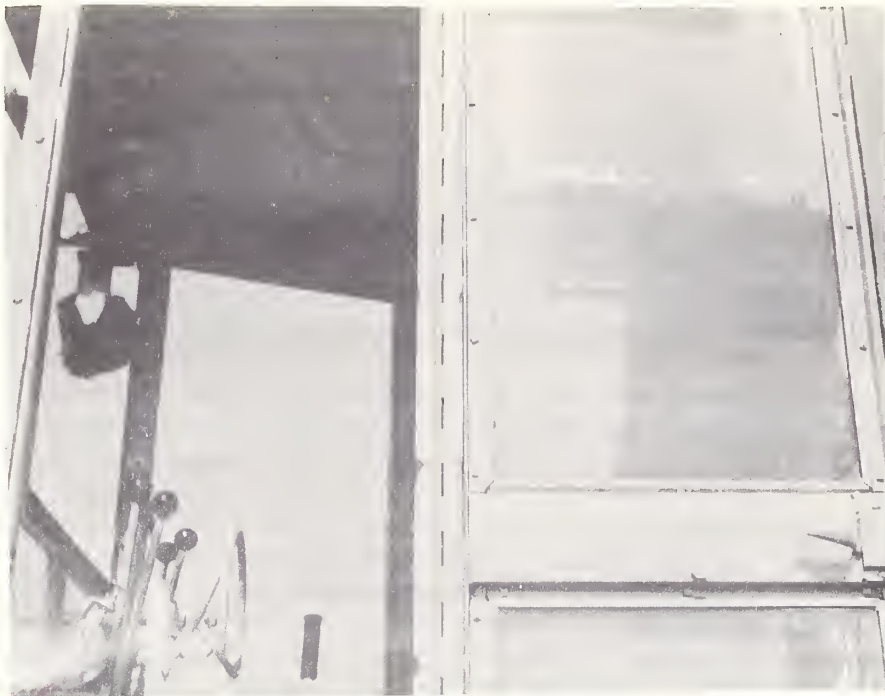
Fig. 23, Door Glass Break

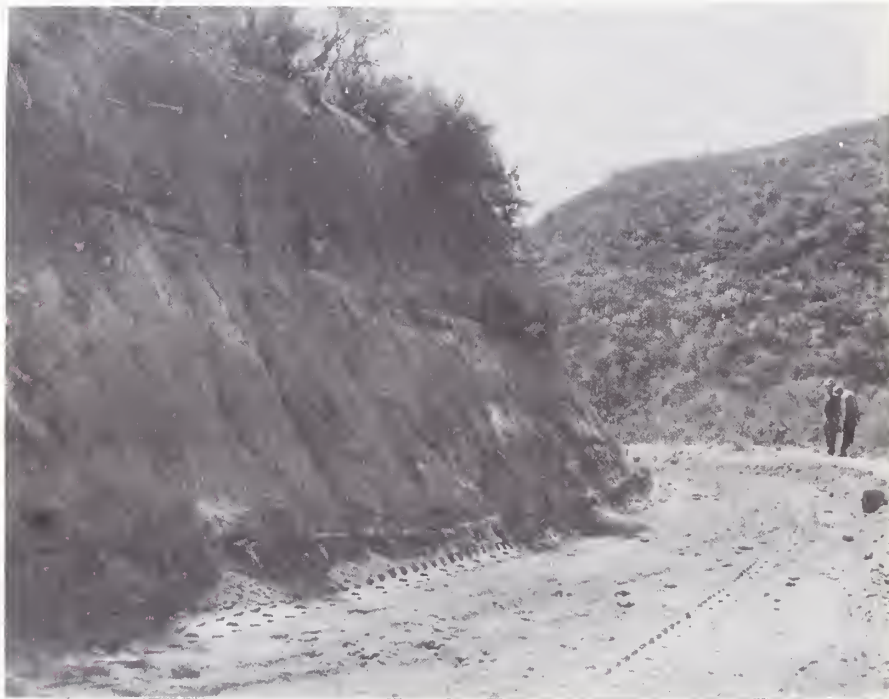
Fig. 32. Rome Bank Slope

The Rome 402 grader was unable to bank slope to a standard acceptable to observers. Photograph, Fig. 32, shows one attempt at this operation. The slope of the bank was such that the tandems could not climb. On the approach to the out-curve in the foreground, the wheels rode as closely to the bank as possible. The tip of the blade barely touched at points. At the out-curve in the center of the picture, the blade was just able to do a partial smoothing job.

Failure of the machine to do bank sloping satisfactorily was attributed mainly to design of the entire blade, circle and linkage assemblies. Conditions anticipated from the "flat land" were proven in this test, particularly as regarding location of blade heel with respect to reference line. The movie sequence of this test clearly shows the position of the blade as well as the futile efforts of the operator to slope the bank.

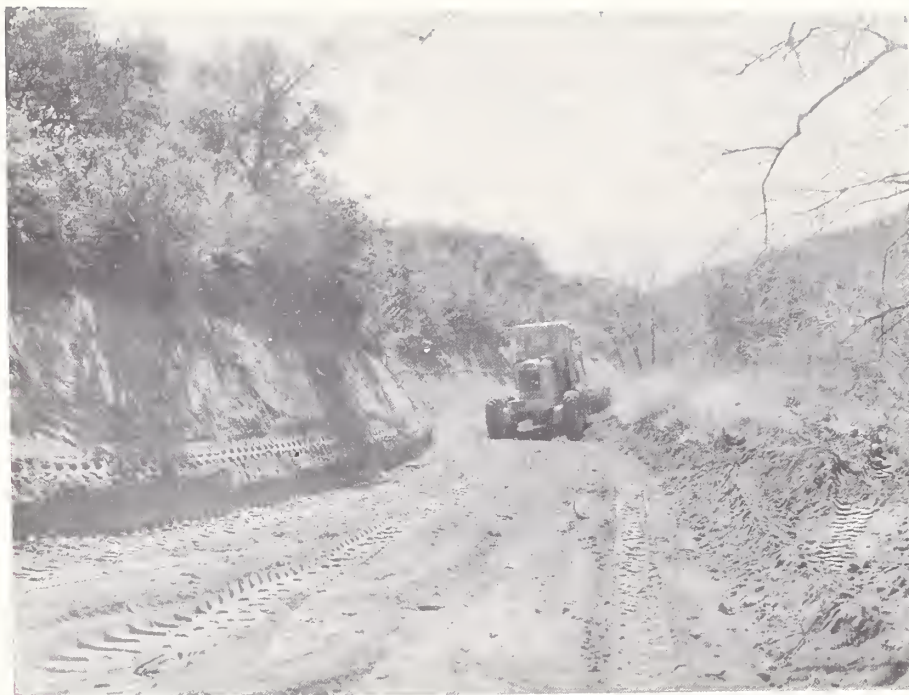
Fig. 33. Rome - Bank Slope

Photographs, Figs. 33 and 34, show other attempts to bank slope with the Rome grader. In both cases, in order to touch the bank, it was necessary for front wheel and rear tandems to climb the slope. In Fig. 34 the numerous wheel tracks are caused by second and third attempts to slope after adjusting the blade and linkage. Final sloping in this case was done when the tandems followed the highest tire track shown.

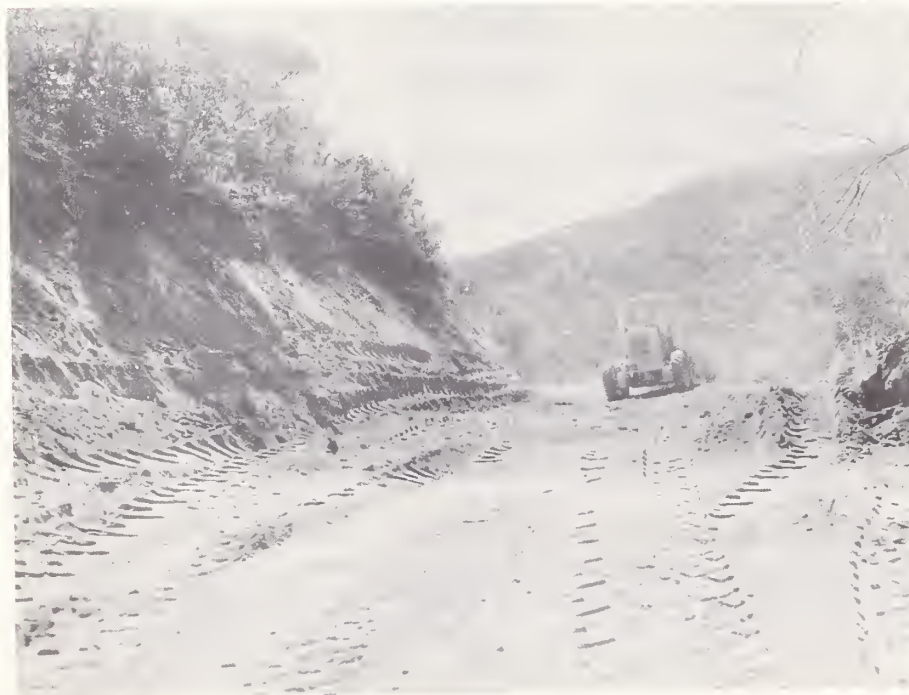
Fig. 34. Rome - Bank Slope

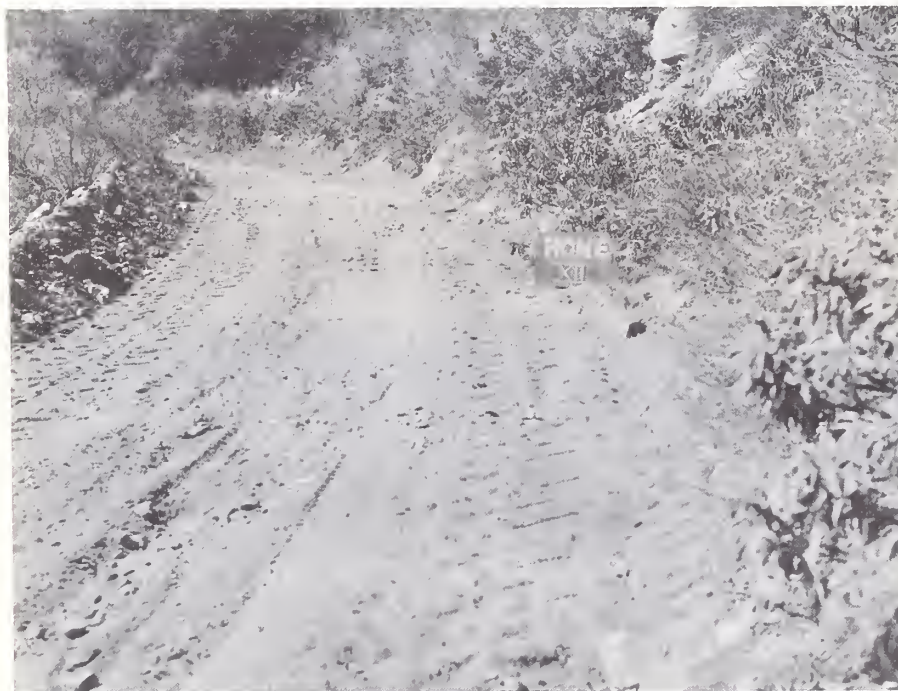
Photograph, Fig. 41, shows an after shot of a piece of fine grading. In the lower left hand corner is shown a condition which was noted on many occasions. A distinct track caused by the dragging of a small rock shows. Study of the photograph indicates that the instant the blade hit the rock it was lifted and a hummock with a fairly large amount of small rocks was deposited. This was a very definite factor in the appraisal of fine grading operations. The cause in most cases was traced to slackness of linkage or air in the hydraulic system.

Fig. 41. Fine Grading

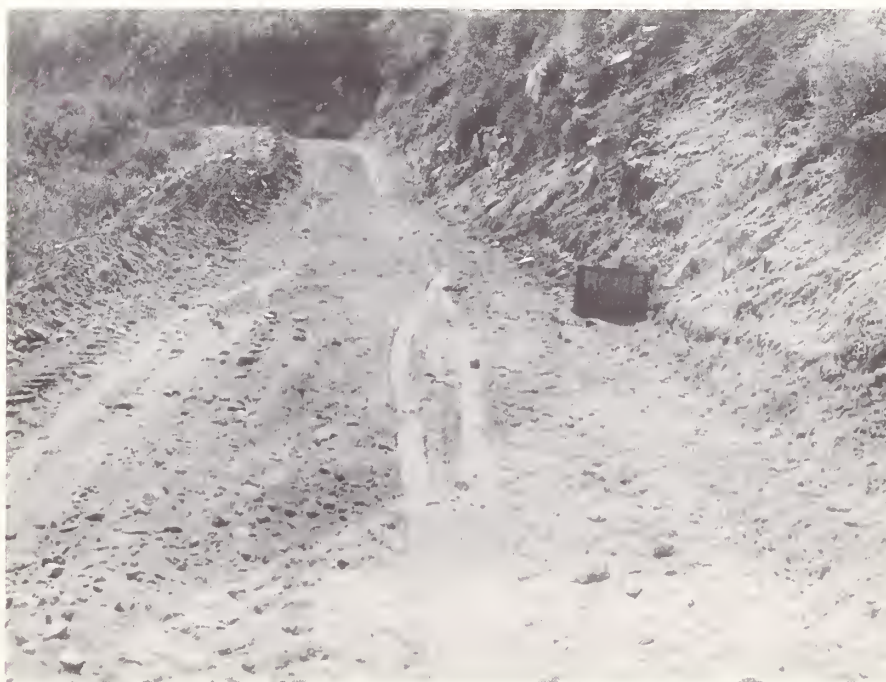
Photographs, Figs. 42 and 43, show before and after conditions of another typical section. The diagonal dirt ridge shown in Fig. 43 is an example of the result of blade instability and lack of control. Throughout the run similar conditions could be found, sometimes in the form of a ridge, other times as a gouge.

Fig. 43. Road Maintenance, After
